**Flood Control Project Maintenance  
Levee Inspections**  
**LMA District Cover Sheet**  
**Spring 2009 Levee Inspection Results**

**Maintenance Area 0016**

**Levee Inspection Report By Mile - Spring 2009**

Waterway	Bank	Unit Miles	Inspection Start/End	Inspector
Unit No. 01 Feather River	Right	4.10	04/30/2009 04/30/2009	Clay Thomas

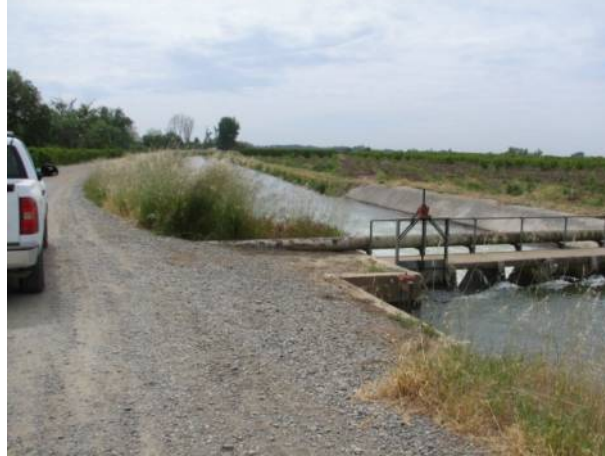
Levee Mile Report Line	9
Start Levee Mile	2.85
End Levee Mile	3.08
Location	Land Side
Category	Earthen Levee
Item	Encroachments

AG ditch land side slope and toe.
